Reference report **Aachener Cathedral, Aachen**

**Test area Aachen Cathedral**

**Building:** Aachener Dom, Germany  
**System solution:** emco **MARSCHALL**, emco **Clean Off**  
**Year installed:** 2020/2021  
**Partner:** F.D. Beissel Fussbodentechnik, Aachen

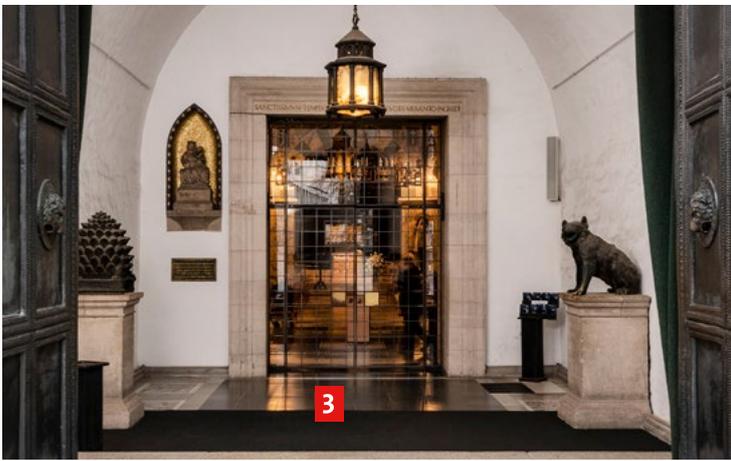
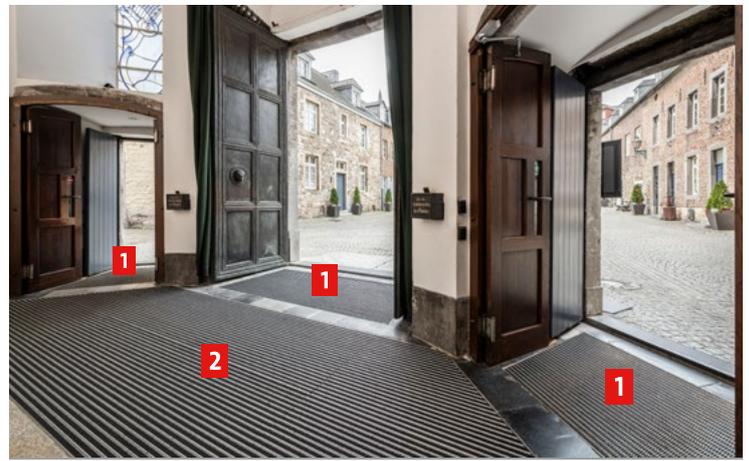
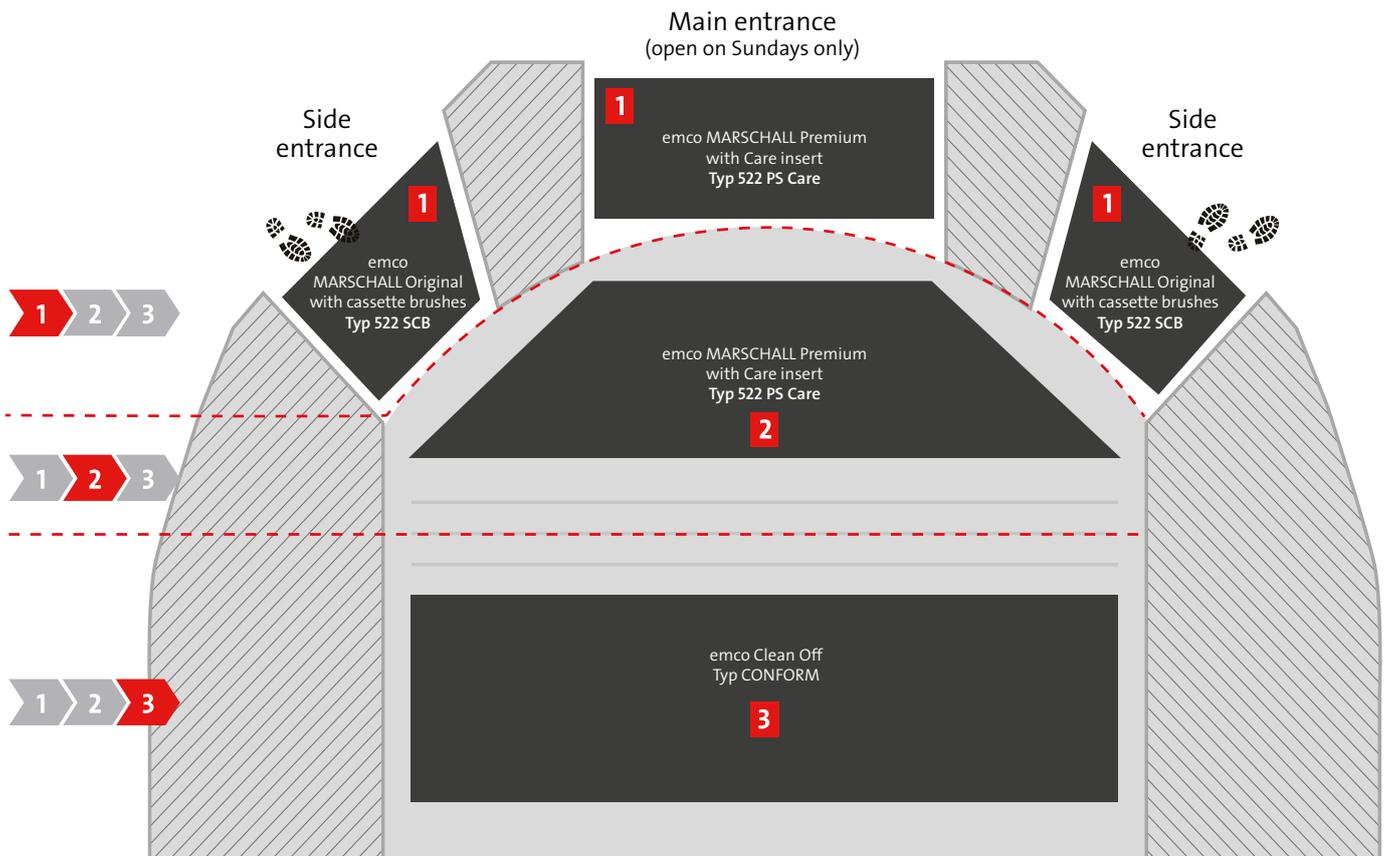
emco **MARSCHALL** Original  
**Typ 522 SCB**  
Cassette brushes black,  
rubber insert

emco **MARSCHALL** Premium  
**Typ 522 PS Care**  
with Care insert

To keep the dirt brought in by visitors to a minimum and to protect the structure as an asset, the emco 3-zone cleaning system was fitted in the entrance area. The special case of the Aachen Cathedral: The Aachen Textile and Flooring Institute (TFI) designated our 3-zone cleaning system a test area. From July 2020 to August 2021, the number of visitors was recorded and the dirt levels were determined in the **emco MARSCHALL Original** (side entrances), **emco MARSCHALL Premium**

(main entrance, or Wolf's Door, and the vestibule), and **emco Clean Off** (at the base of the stairs). Over the observation period, **423,218** people passed through the entrances. TFI employees cleaned the entrance mats every week to determine the dirt levels and scanned the material to document changes in appearance.

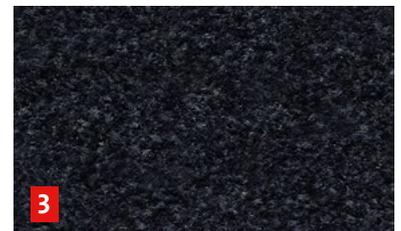
emco **Clean Off**  
**Typ CONFORM**  
anthracite  
Material: 1/8' tufted velour 100%  
polyamide ECONYL®
